A.U.W.E Tech Note 192/65 Part 3

A CORROSION STUDY ON MATERIALS
FOR USE WITH PHOSPHORUS & SULPHUR
BEARING FUELS

ADMIRALTY UNDERWATER WEAPONS ESTABLISHMENT
PORTLAND

EXAMINATION OF COMBUSTION CHAMBER COMPONENTS ETC.

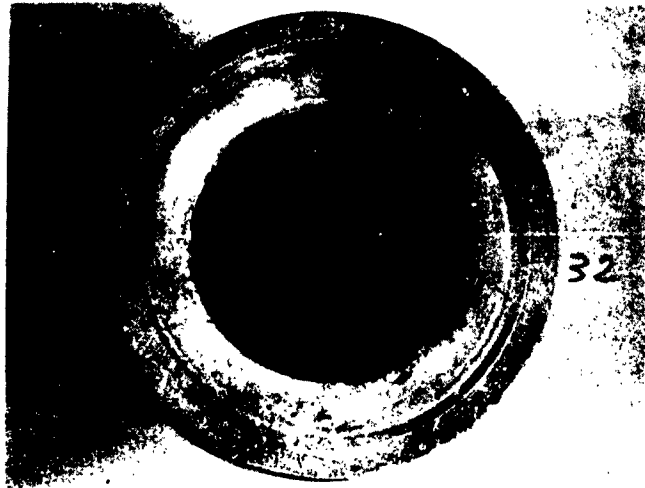
FIG 14

28. The upstream surface of the nozzle was covered with a green deposit of metaphosphate (Figure 14). The throat area showed evidence of coating failure due to blistering. The exhaust area was badly blistered and showed deposits of solid corrosion product. The rear face of the nozzle was also damaged (Figure 15).

30. The examination failed to show positive evidence of direct chemical reaction between combustion phases and the protective gold. It is considered that the damage to this component was caused by

- (a) chemical attack of the base metal through cracks and pores in the protective coating,
- (b) the action of the fast moving gas/liquid acid stream over the soft gold layer.

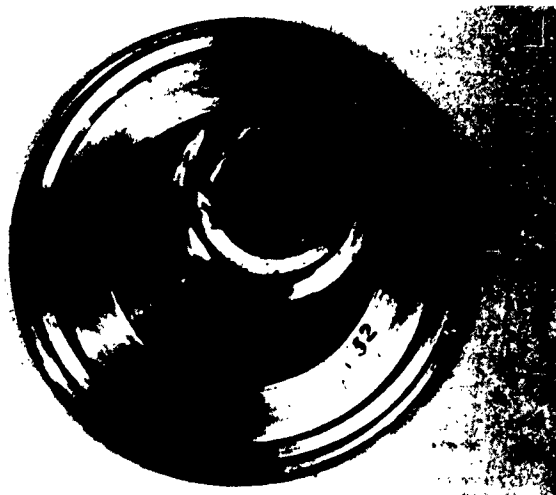
FIG 15

29. Metallurgical examination revealed that the blistering may have resulted from the effect of heat on poor quality plating. Irregular pile up of gold 0.030 inch thick appeared on the downstream surfaces. Areas were visible where the gold had been completely removed leaving the base metal exposed to the combustion gases.

31. However it is difficult to account for the large pile up of gold on the downstream surfaces unless the temperature within the chamber was higher than 400°C.

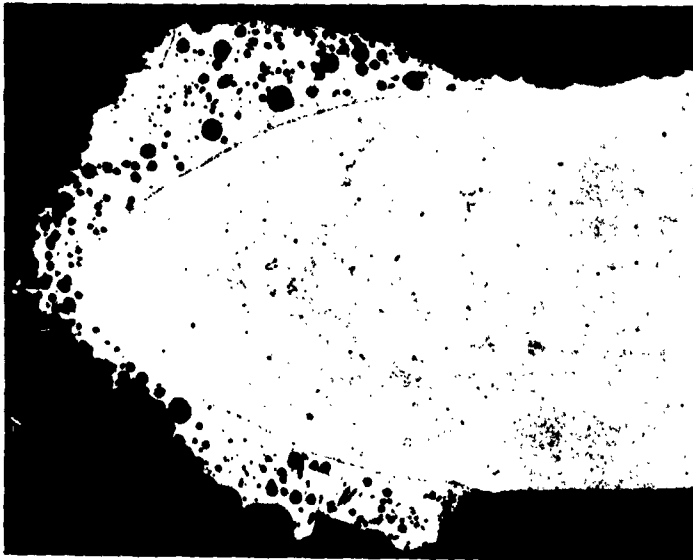
FIG 20

35. The tip of the exposed end had been completely removed while the remainder appeared to be covered with a dark metallic deposit. This deposit was subsequently found to be extremely hard and porous (Figure 20).

39. The porous nature of the deposit may have resulted from a gas-forming reaction similar to that of "carbon boil" in steel making. This would require removal and oxidation of carbon from the silver steel/deposit to form carbon monoxide by the reaction

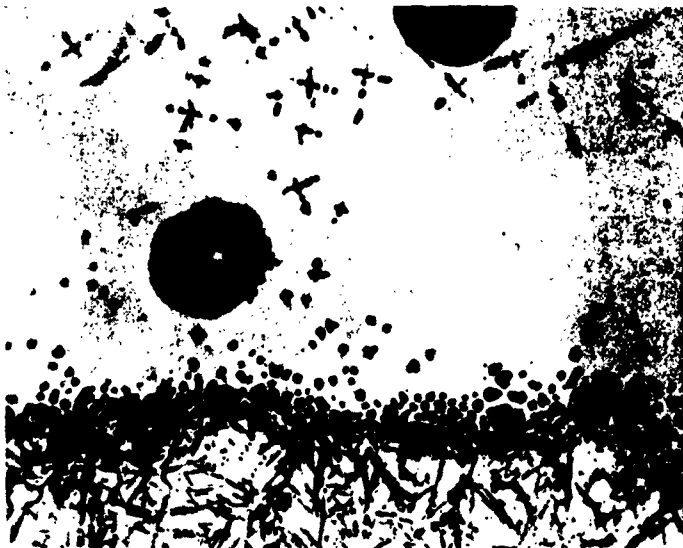
FIG 21

36. Microscopical examination of a longitudinal section cut from the rod revealed a rapid change in microstructure between unexposed and exposed areas. The former showed a spheroidised structure related to that of the original condition of the material. The latter was found to consist of coarse martensite, a structure normally associated with heating to temperatures above the upper critical followed by rapid cooling. The deposit was found to contain primary dendrites of martensite in a fine eutectic matrix. Figure 21 shows the structure after etching at the steel/deposit interface.

38. Although phosphorus was found in the deposit, the eutectic matrix was considered to be essentially transformed Ledeburite. This structure probably resulted from a temperature exceeding the equilibrium liquidus i.e. for silver steel approximately 1350°C.
